# Delo® Testimonial: Freestate Petroleum Distributors

## Achieves 1,000,000+ kilometres in a Freightliner® Truck using Delo® family of products.

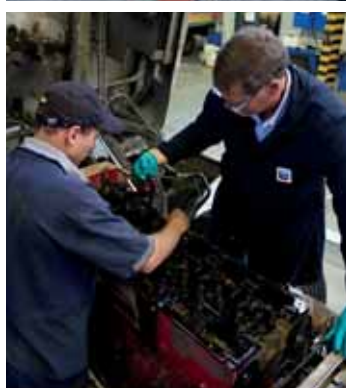
The final inspection overall showed a clean engine with minimal deposits and wear on the key engine components. The pistons showed minimal deposit buildup on the crown and top ring land zone. The camshaft lobes showed excellent wear protection and no visible wear scars on rollers or rocker arms. Bearings also were in very good shape with only small amounts of overlay removal – excellent for an engine with this many kilometres at high load.
